National Aeronautics and Space Administration

NASA-DoD Lead-Free Electronics Project

DRAFT Joint Test Report

July 2011

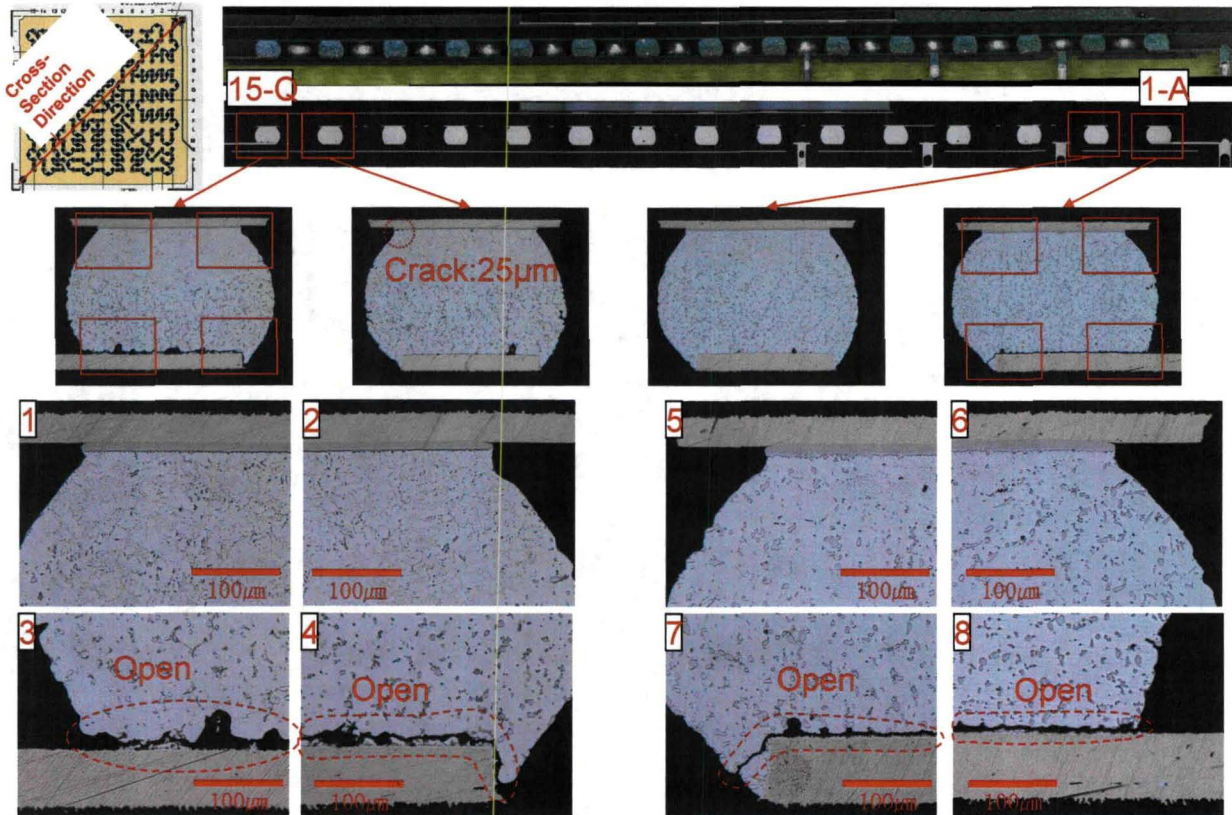
Figure 50 - TV23 U43; Cross-Sectional Micrographs

Cross-sectional micrographs in Figure 50 show different solder structure in lands on board (3, 4) and lands on component (1, 2). Cracking to open along land on board observed at 1-A and 15-Q.

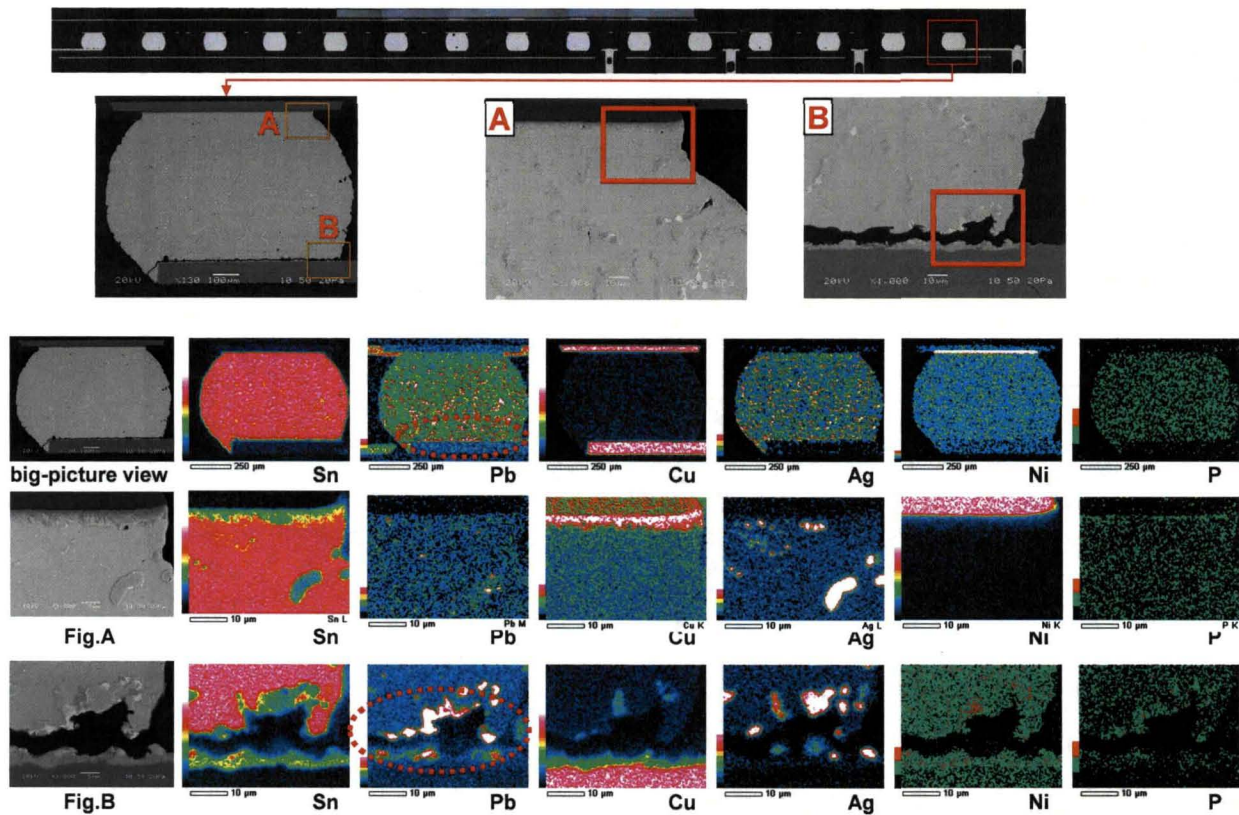
Figure 51 - TV23 U43; SEM Mapping

In Figure 51 SEM mapping shows segregation of Pb around land on board. Cracking found in the part Pb segregated.

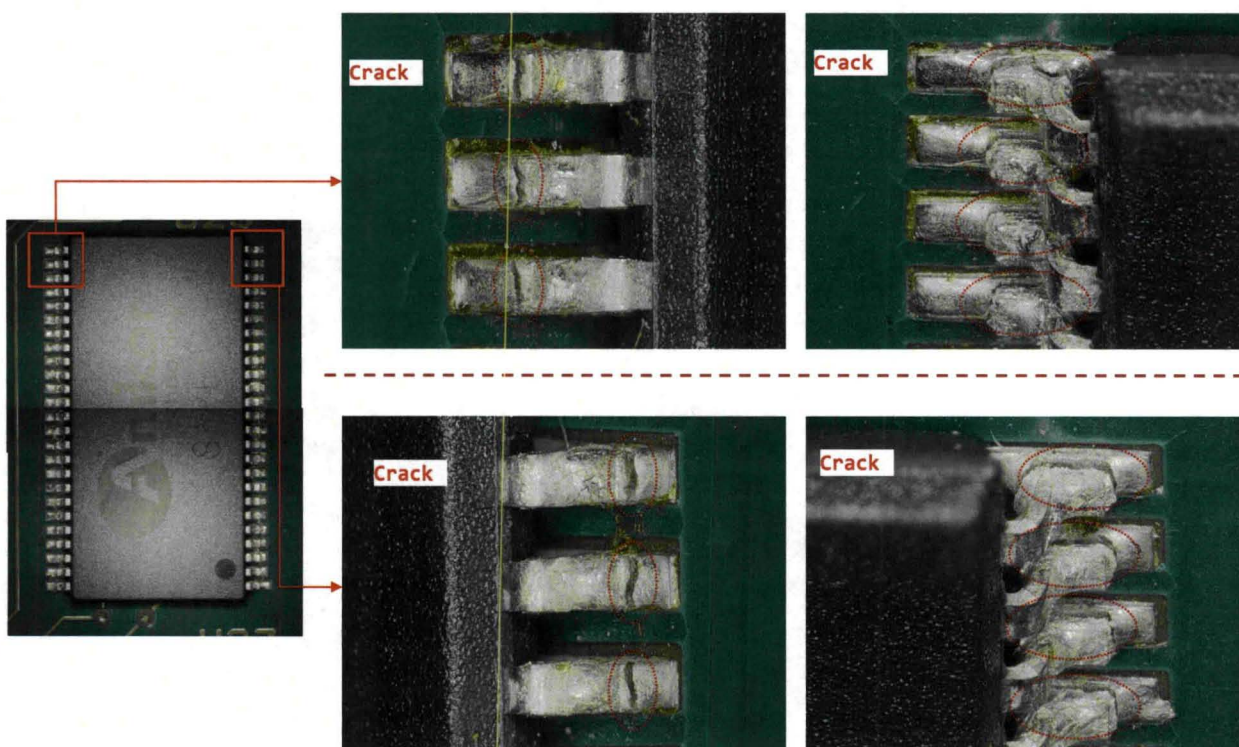
Component location U29 is a TSOP-50 soldered with SAC305 on SnPb component finish. This component failed at 161 cycles of combined environments testing.

Figure 53 - TV72 U29; Visual Inspection Showing Cracked Solder Joints

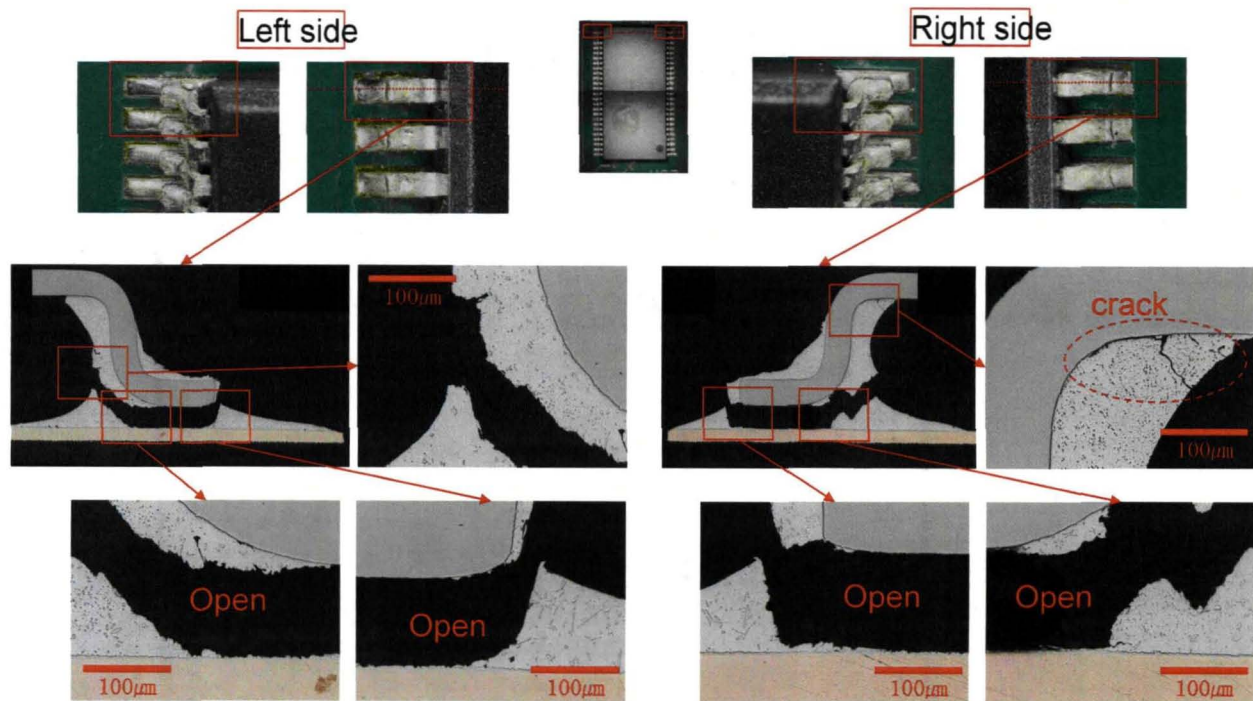
Figure 54 - TV72 U29; Cross-Section Micrographs Showing Open Solder Joints

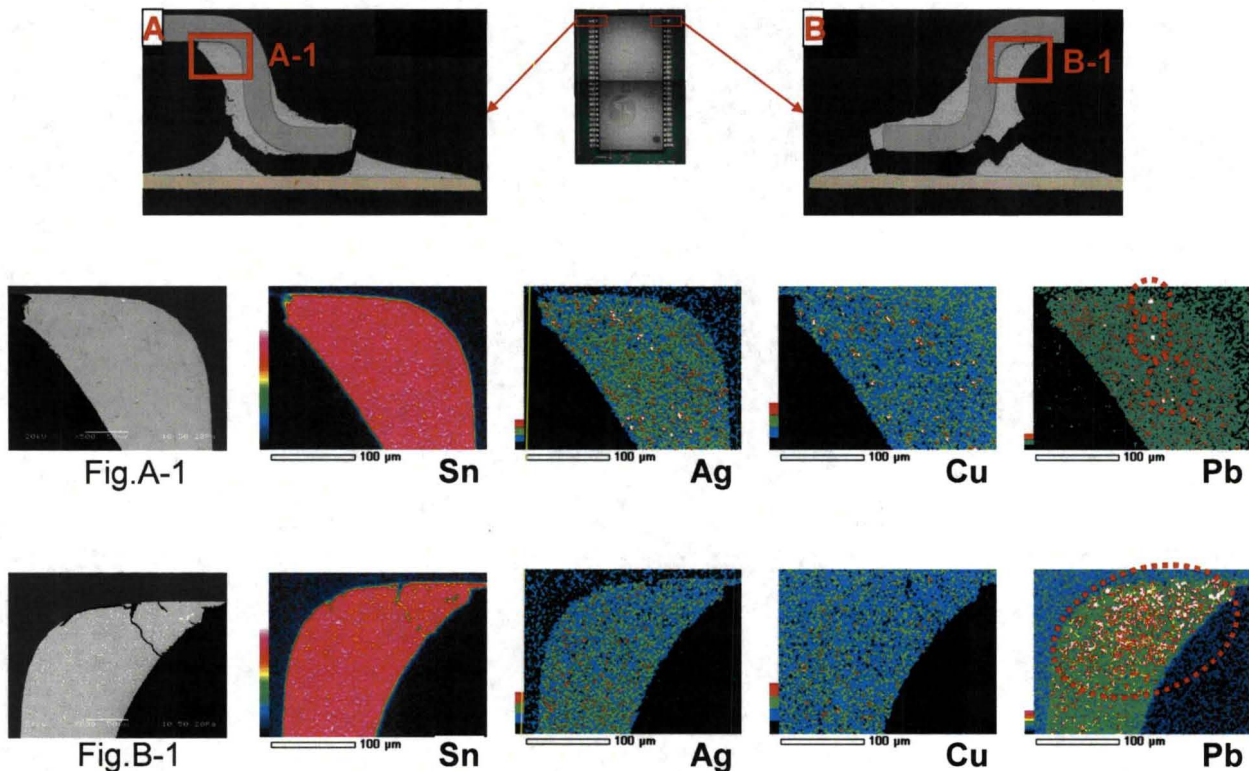
As observed in Figure 55, more Pb was found from the right lead. Source of Pb is from the lead plating.

Figure 55 - TV72 U29; SEM Mapping, Pb was Found Around Upper Part of the Both Leads

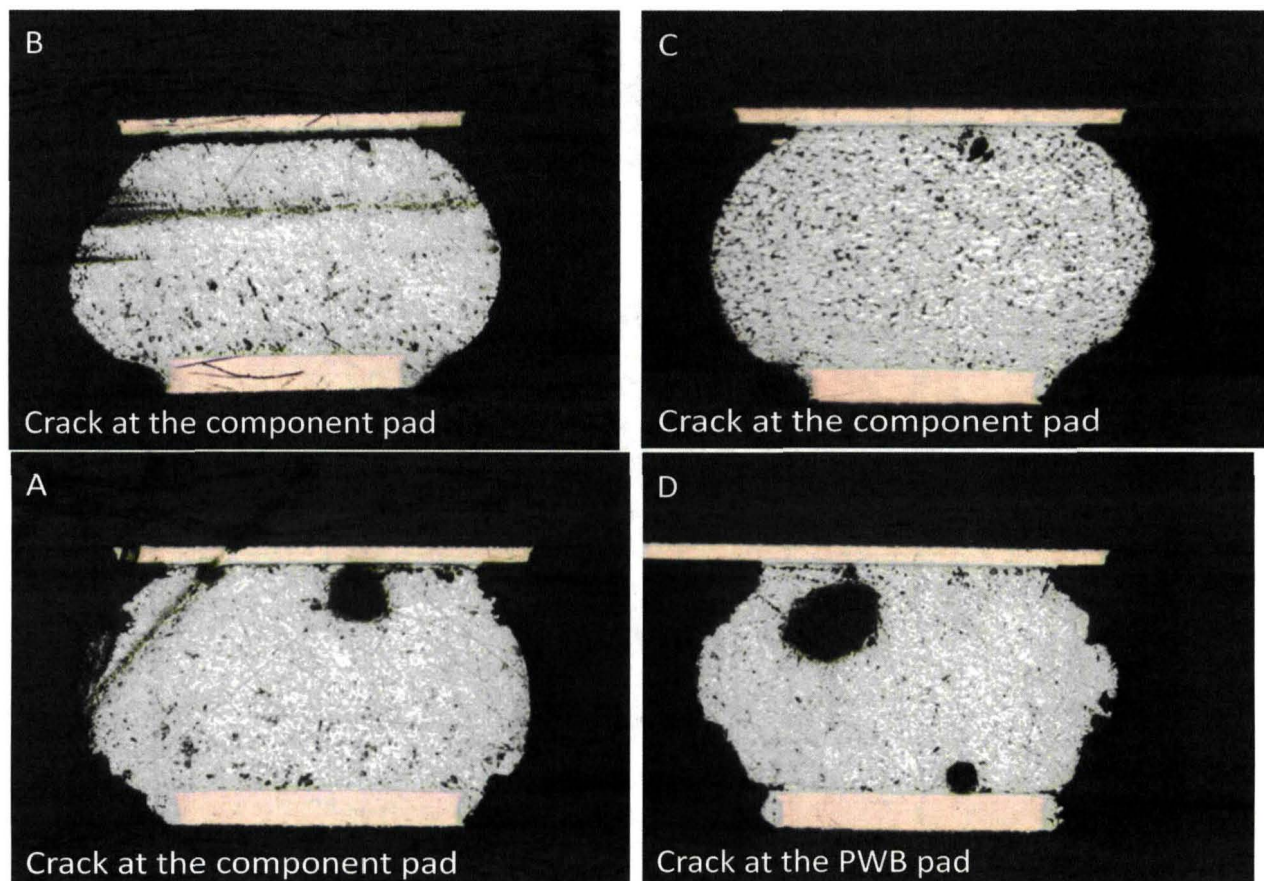
Figure 57 - TV117 U4; Cross-Sectional Micrographs of Corner Solder Balls

Figure 57 shows cross-sectional micrographs of corner solder balls depicting cracks at component pads on views A, B and C. Crack at the PWB pad detected on view D.

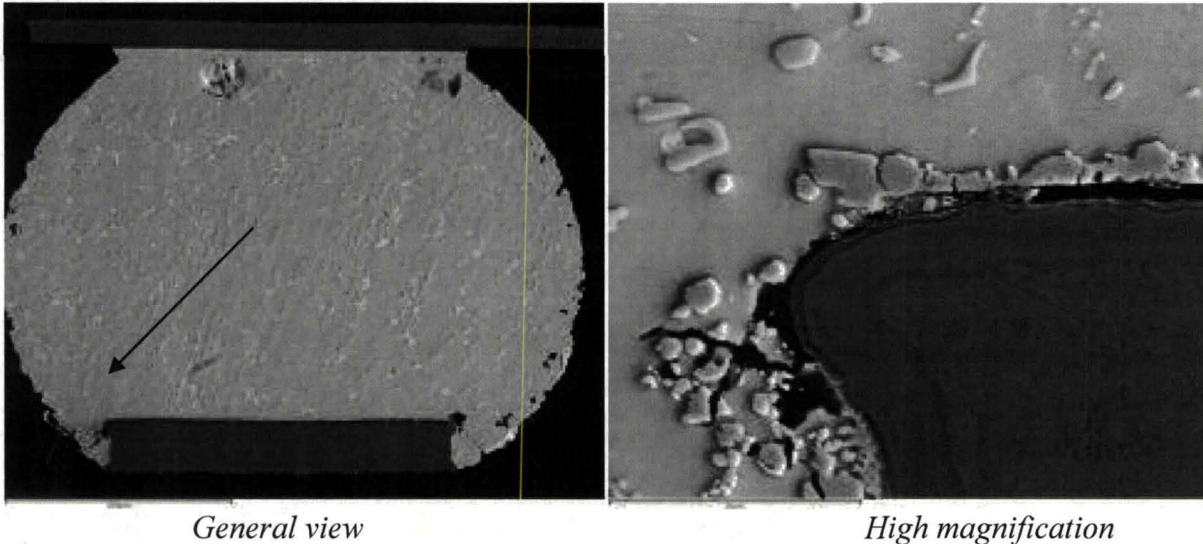
Figure 116 - SEM of Brittle Intermetallic Failure on BGA225

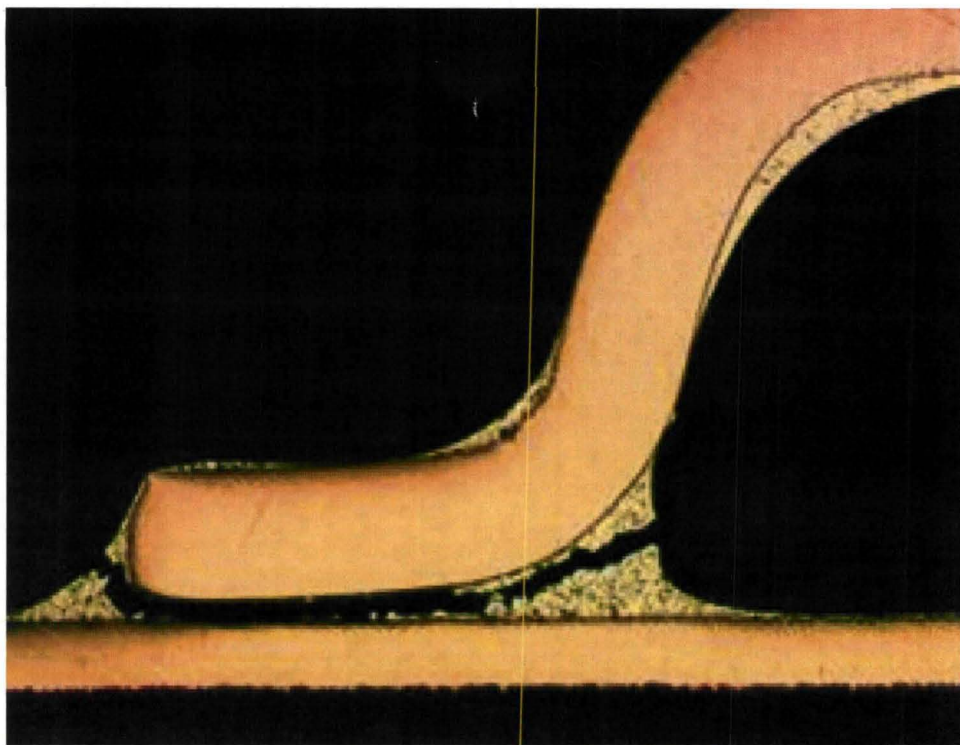
Figure 120 – Fatigue Failure of TQFP-144 with 1x Rework as seen through cross sectioning
